**2017 NDIA GROUND VEHICLE SYSTEMS ENGINEERING AND TECHNOLOGY
SYMPOSIUM
POWER & MOBILITY (P&M) TECHNICAL SESSION
AUGUST 8-10, 2017 - NOVI, MICHIGAN**

**SILICONE BRAKE FLUID COMPATIBILITY WITH ANTI-LOCK
BRAKING SYSTEMS FOR IDENTIFYING FUTURE MILITARY BRAKE
FLUID REQUIREMENTS**

Zackery Schroeder
Talia Sebastian, PhD
US Army TARDEC
Ground System
Performance Fluids
Warren, MI

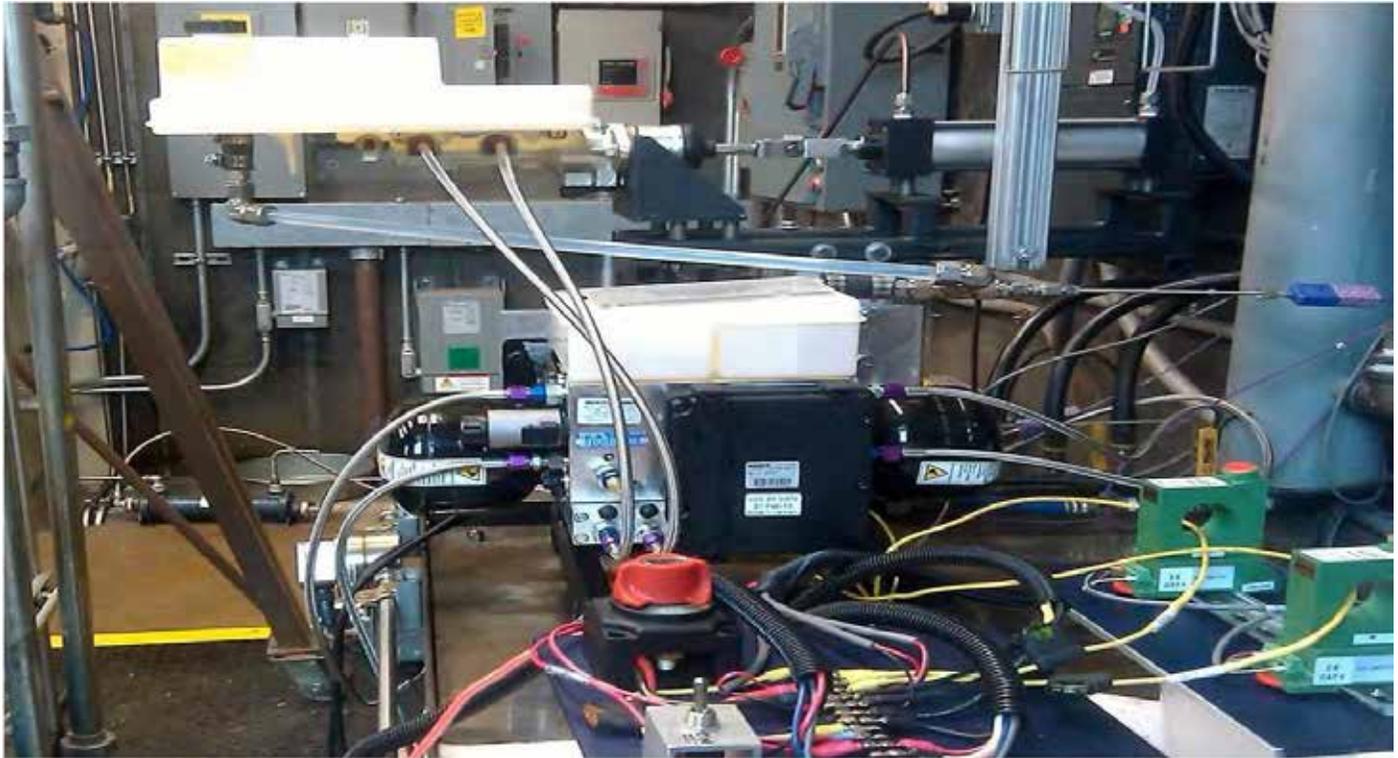
To reproduce conditions of heavy duty ABS use, an ABS test stand was designed (Figure 1). The ABS test stand unit consisted of independent front and rear breaking circuits. Each breaking circuit had an electric motor that drove a pumping element used to maintain braking pressure, a gas charged accumulator to store circuit pressure, and a pressure transducer for measurement and control. Each circuit also had two independent wheel circuits, right and left, which contained two servo valves for each wheel. One servo valve was responsible for controlling pressurized fluid to the brake calipers, while the second servo valve was responsible for brake release and relieving caliper circuit pressure back to the reservoir. The brake circuit was initiated by pressure from the master cylinder through the

Figure 1. Anti-Lock Brake System Test Stand Unit

A service software tool was utilized to control the ABS test stand without the need for wheel sensors. In short, the ECU software was used to dump the accumulator pressure. This then resulted in venting the brake fluid across a filter, shearing the fluid, and returning back to the reservoir. This action then triggered the ECU to turn on the pump motors to raise the system pressure again and cycle the fluid. This “pump and dump” cycle was to be repeated until deposition was observed to occur on the pump inlet filter mesh screen and/or the pump inlet filter mesh screen collapsed.

and more motor operational time than a conventional master cylinder and brake approach. A Polyethylene Terephthalate (PET) viewing window, compatible with both fluids, was machined into the hydraulic reservoir to allow for the monitoring of residue deposition on the pump inlet filter mesh screen and/or pump inlet filter mesh screen fidelity.

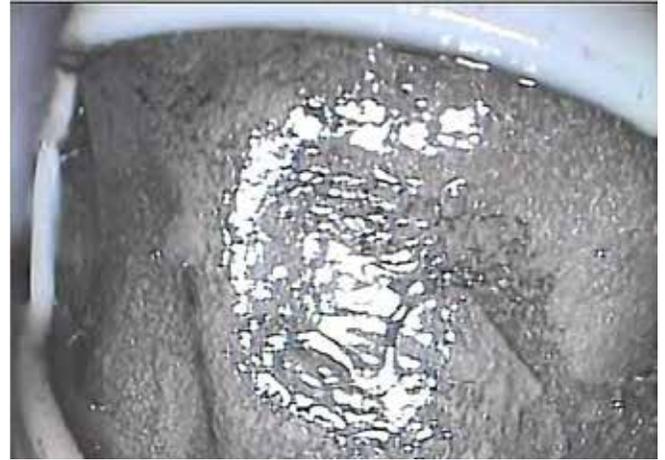
At 20,000 cycles, it was finally observed that the filter media appeared to be collapsing. Figure 3 details the filter media after 20,000 cycles. From the figure it can be observed that the pumping inlet filter mesh screen at 20,000 cycles was covered with particulate laden viscous fluid and had wrinkling likely due to elevated differential pressure due to particulate deposition. Although spot checking during cycling revealed deposit and metallic particulate build up, the filter fidelity had

Figure 3. Pumping filter inlet mesh screen after 20,000 pump and dump cycles with SBF.

not yet been compromised. This observation indicated that metal particles were present within the fluid, suggesting that deposit and metallic particulate wear were occurring within the ABS test stand unit. Testing on the SBF ABS test stand unit was then halted. The SBF ABS test stand unit was then decommissioned and subjected to physical analysis of the components and chemical analysis of the 20,000 cycle fluid and servo valve filters, elastomer seals, deposits and particle accumulations on pump inlet filter mesh screens.

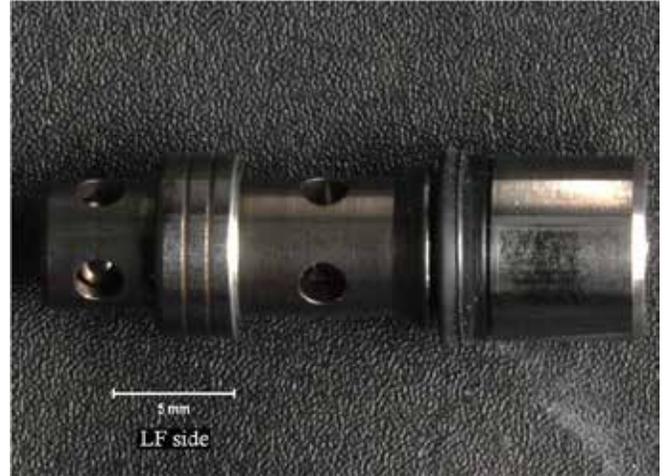
under high magnification for wear analysis. Figures 4 and 5 display the overall condition of both the pumping (left) and follower (right) ends the front plunger of both the SBF and DOT III ABS test stand units respectively. The DOT III front plunger was observed to have less polish. Wear was observed on the follower end of the SBF front plunger, as well as distress to the elastomeric seal. In comparison, very little distress was observed on the elastomeric seal of the DOT III front plunger. Figure 6 and 7 display the overall condition of both the pumping (left) and follower (right) end of the rear plunger of both the SBF and DOT III ABS test stand units respectively. Wear was observed on both the pumping and the follower end of the SBF unit, while the DOT III was again observed to have very little polishing. As well, more distress to the SBF rear plunger elastomer seal was observed, while very little distress was observed for the elastomer seal of the DOT III rear plunger.

Figure 4. SBF front plunger. Pumping end (left), follower end (right).

of both tests suggests that SBF is slightly less lubricious, which could explain the increased wear seen on the system pumping plungers and corresponding barrels that match these results.

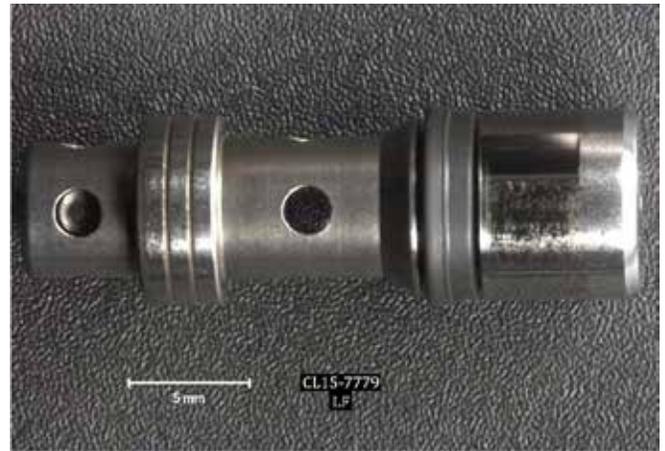
Figure 5. DOT III front plunger. Pumping end (left), follower end (right).

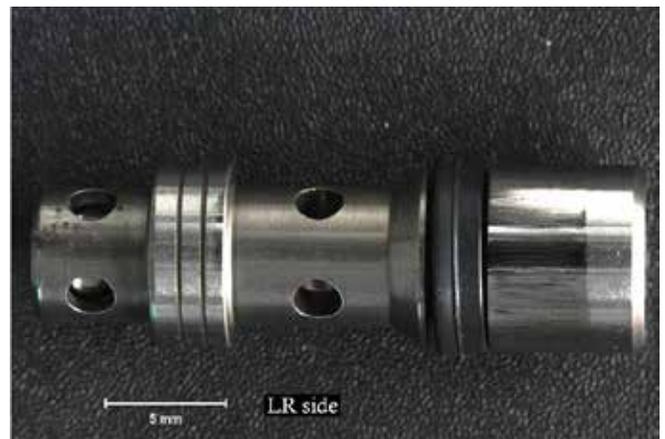
Figure 6. SBF rear plunger. Pumping end (left), follower end (right).

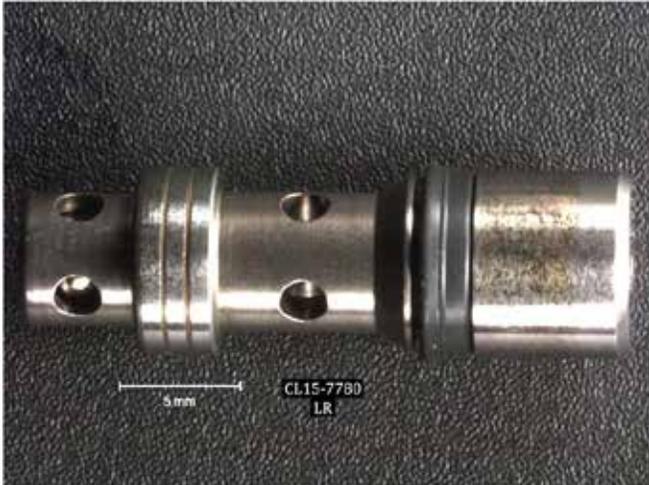
Figure 7. DOT III rear plunger. Pumping end (left), follower end (right).

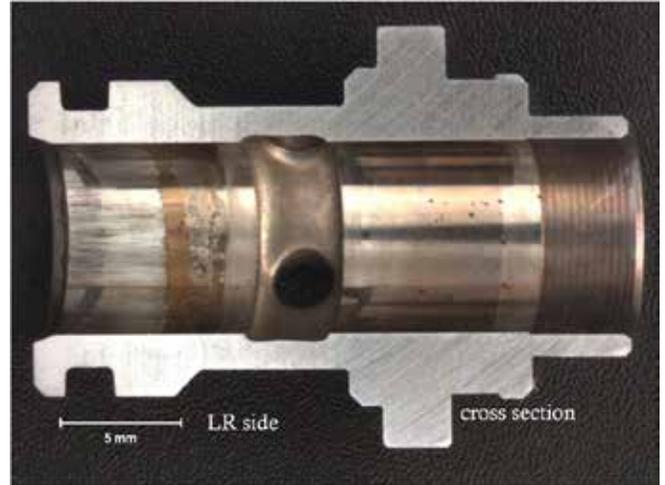
Figures 8 and 9 display the cross-sectioned barrels of both the SBF and DOT III front plunger respectively. Wear from the SBF front plunger follower section was observed, while the corresponding barrel of the DOT III was observed to have very little wear from the DOT III front plunger follower. Elastomer distress was observed for the SBF unit front plunger. Debris from the SBF front plunger and barrel wear at the follower end is believed to be the cause for the elastomer distress. Figures 10 and 11 display the cross-sectioned barrels of both the SBF and DOT III rear plunger respectively. Wear and material transfer from the SBF front plunger follower section was again observed, while the corresponding barrel of the DOT III was again observed to have very little wear. As well, elastomer seal distress was again observed for the SBF unit rear plunger. Debris from the SBF rear plunger and barrel is again believed to be the cause for the elastomer distress.

Figure 10. SBF rear plunger barrel cross section.

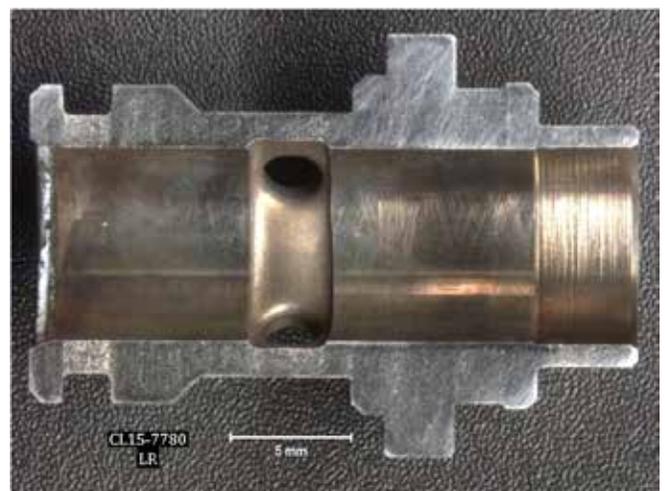
Figure 11. DOT III rear plunger barrel cross section.

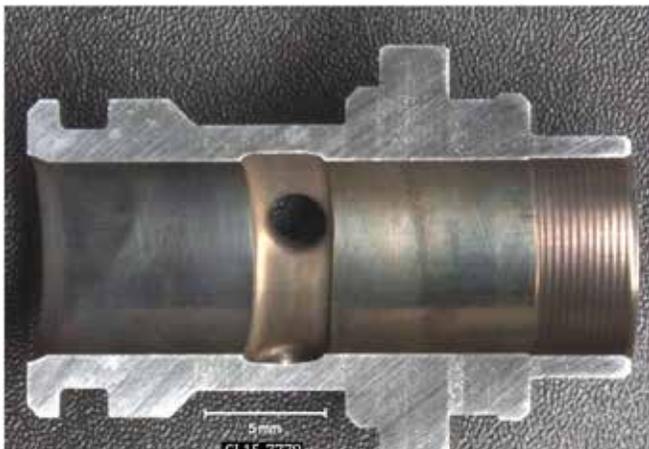
Figure 9. DOT III front plunger barrel cross section.
