**Investigation of Hot Cracking Phenomena in Light-Weight Armor  
Steel Based on the FeMnAl-C Alloy System**

**William Evans**  
**Antonio J. Ramirez, Ph.D.**  
Department of Welding Engineering  
The Ohio State University  
Columbus, OH

**Abstract**

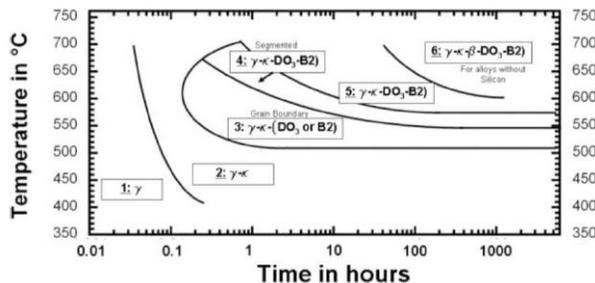
**Figure 1:** Time temperature transformation curves for 1.25 wt.% Si FeMnAl alloy

Carbide precipitation follows a classical age-hardening reaction [2]. In which, precipitates can be coarsened to a peak-aged condition, usually exchanging ductility for strength. Therefore, there are several procedures that can be conducted to tailor the properties of this alloy system. It has been reported that for maximum ductility and toughness, the heat treatment should aim for the largest volume fraction of austenite. An age hardening curve for a FeMnAl alloy is displayed below in Figure 1 [2].

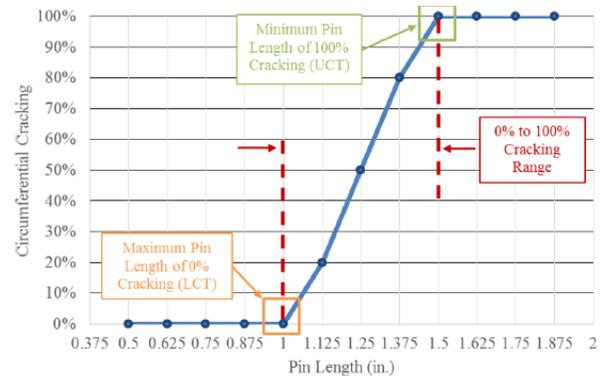
**Figure 2:** CPTT average cracking response curve labeled with ranking criteria

This test allows for the response of an alloy to be compared to other alloys with known susceptibilities [13]. The average percentage of the circumference which is covered in cracks is reported versus the length of the pin. An example graph is shown in Figure 2. This test is good for comparing different heats of material, and new experimental alloys because it utilizes much less material compared to other weldability tests.

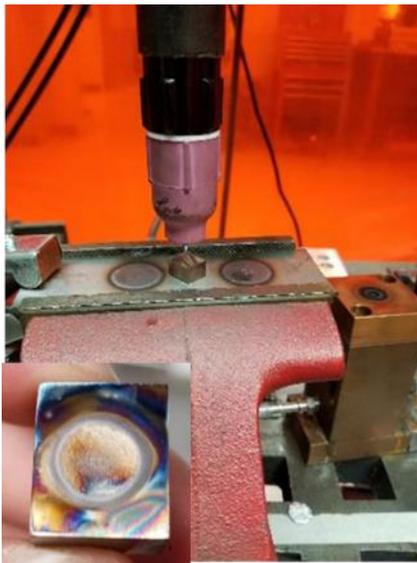
**Figure 3:** GTA spot welding set up with an image of the sample spot weld in the lower left corner

To simulate a weld fusion zone, and a weld HAZ, a small piece of material was sectioned from the cast plates and a melt pool was created using a GTA spot weld. The melt pool was created on a cleaned face of the material, and was cross sectioned for optical microscopy.

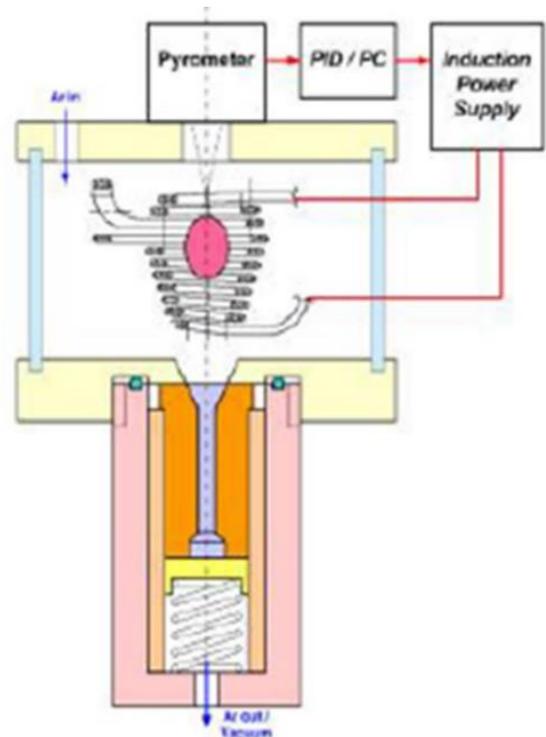
**Figure 4:** Schematic of the cast pin tear testing apparatus

The CPTT was conducted in similar fashion to previous studies conducted at OSU. The main example being work conducted on high Mn steels conducted by M. Orr [14]. A schematic of the testing apparatus is shown below in Figure 4.

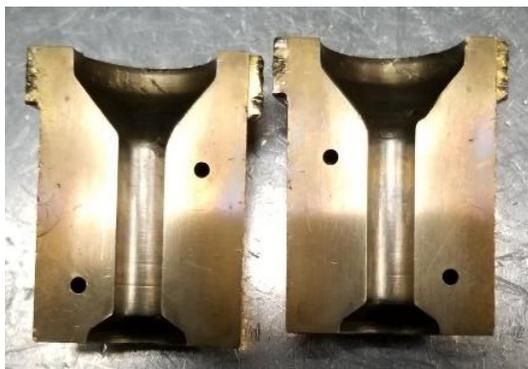
Figure 5: Example of CPTT pin mold

When dropped into the mold the material will begin to solidify from the bottom of the mold to the top. Located at the top of the mold is a stress riser which is intended to create a region in the pin where an adequate level of stress is created to induce solidification cracking.

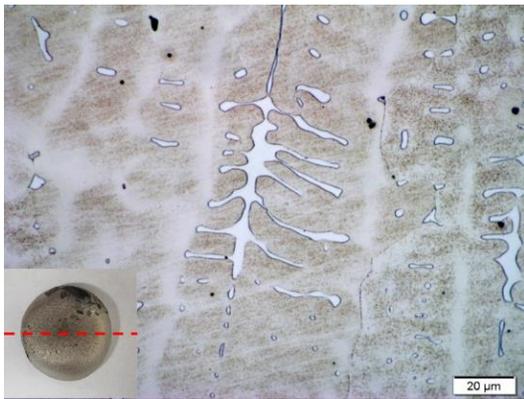
**Figure 6:** Micrograph of FeMnAl cast button microstructure. The matrix is austenitic FCC, and the light region is interdendritic Ferrite. An image of the as cast button before sectioning is shown in the lower left hand corner

The initial cast structure investigated using OSU's button melting system is shown in Figure 6. The microstructure reveals a fully FCC matrix, with interdendritic ferrite, and carbide "peppering" throughout the matrix. This structure is very similar to the cast microstructure seen by Howell et. al. [2]. No additional processing steps were taken on this sample. Segregation of the ferrite phase was well dispersed in the center of the button, but was more concentrated towards the edges.

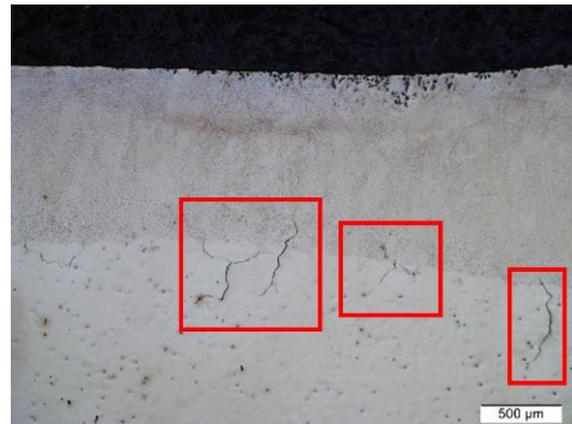
**Figure 7:** Cross section of autogenous spot weld. HAZ liquation cracks are highlighted in the CGHAZ extending into the fusion zone

The autogenous weld fusion zone (Figure 7) created using a GTA spot weld revealed a similar solidification structure as observed in the melt button. Significant segregation of the interdendritic ferrite was also observed in the fusion zone. A small crater was observed at the top of the weld, this was most likely caused by material shrinkage during solidification. The weld HAZ exhibited grain growth, with ferrite along the grain

boundaries. Several cracks appeared in the coarse grain HAZ, and the partially melted zone of the HAZ. These cracks are most likely HAZ liquation cracks which was associated with the interdendritic ferrite that segregated to the grain boundaries. This is evident from what appears to be ferrite scattered along the cracks. It is theorized that the liquidus temperature of the ferrite has been reduced due to the segregation of Al into the alpha ferrite phase during solidification. This needs to be confirmed through additional chemical analysis, and additional computer simulation. No solidification cracks were exhibited in the cast button sample, but the presence of a crater, and a high level of interdendritic phases in an FCC matrix can give evidence to a susceptibility to this cracking phenomenon.

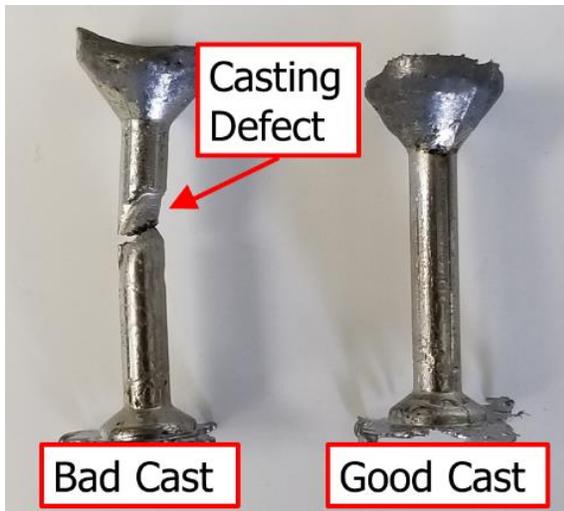
**Figure 8:** Image of two sample 1 inch pins. One pin exhibits cracking due to a casting defect, and the other is an ideal cast pin.

The second round of CPTT was conducted to get a complete response of the material, this means that several pins were taken at each length in an attempt to attain several defect free pins. The high Mn content of the FeMnAl made it difficult to get clean defect free pins, an example of a pin with and without defects is displayed in Figure 8. The high vaporization of Mn leads to difficulty in controlling the casting temperature of the charge. This makes the repeatability of the test difficult. Below in Table 2, and Figure 9 is the data from this round of testing. The table displays a list of the pin lengths tested, and the average percent cracking in the respective pins. Figure 9 shows a plot of pin length versus cracking percent.

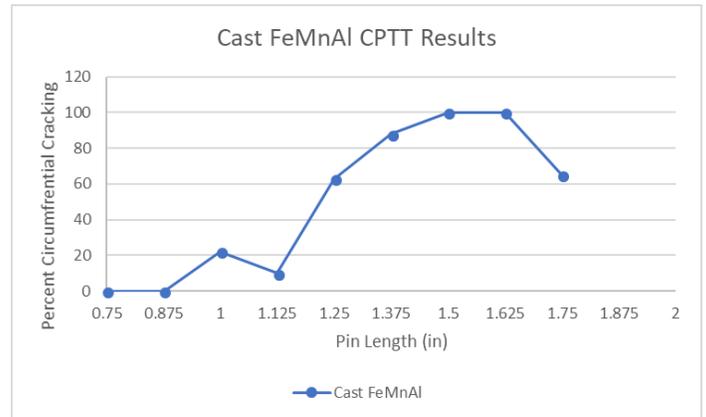
**Figure 9:** FeMnAl CPTT results exhibiting average crack percentage versus pin length

No observable cracking occurred in pin lengths under 1 in. At 1 inch several small cracks occurred on the surface, these cracks are displayed in Figure 10. Similar cracks were seen at 1.125 inch, and 1.25 in pins. Macroscopic cracks that could be observed with the naked eye were not observed until 1.5inch pins. Above 1.5 inches large cracks were seen in all samples. Images of cracking observed in these pins is shown in Figure 11. From these observations a pin length of 1 inch was determined to be the LCT of this alloy.

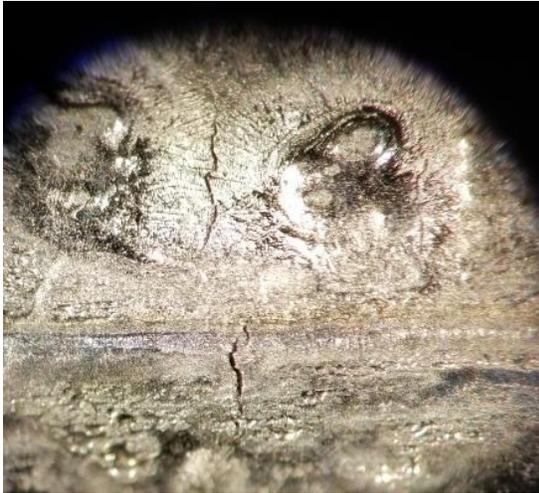
Figure 10: Image of solidification cracks in a 1 inch cast pin

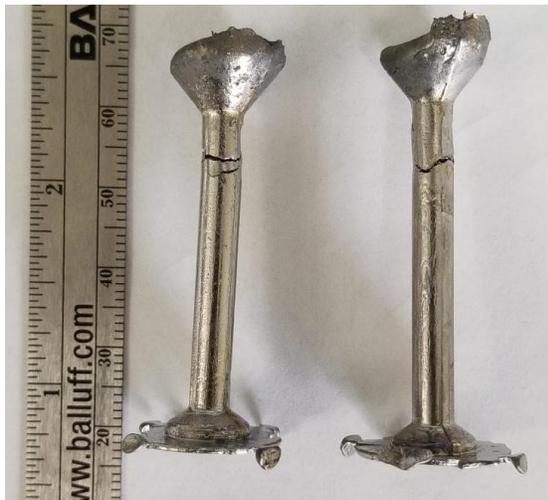
Figure 11: Examples of cracking in 1.375 inch and 1.5 inch cast pin

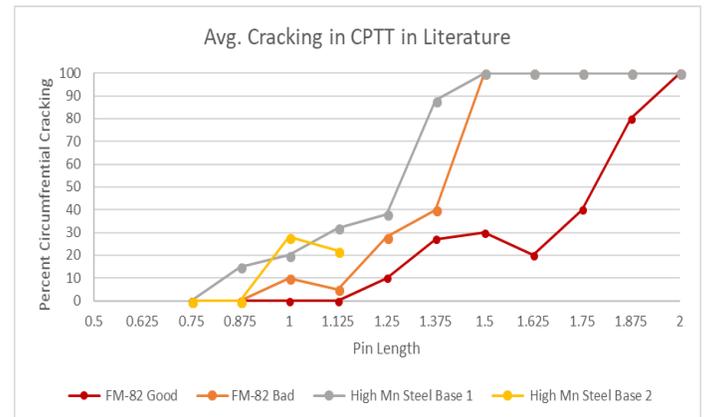
Figure 12 CPTT results shown in two thesis studies conducted at OSU by M. Orr, and J. Lenzo. The cracking response is shown for FM-82, and High Mn steels.

This data can be compared to other cast pin tear testing results previously done at OSU. Figure 12 displays data presented in two thesis studies conducted at OSU, which utilized CPTT on two different materials. The first study was conducted by M. Orr [14], who studied the cracking response of different heats of Ni-base filler metal FM-82. The two heats are broken down into an alloy with a “good” cracking response, and the second heat exhibits a “poor” cracking response. The second study was conducted by J. Lenzo [15], who was examining the

cracking response of high Mn steels. The exact composition of these alloys is not known due to the proprietary nature of this study, but the response of the alloy with additions of B and W was studied. Displayed in this figure are only the base compositions, this is due to the fact that the cast FeMnAl utilized in this study had no additions of W or B. These Mn steels exhibited fully FCC solidification, and showed some similarities to FeMnAl. While these two examples are not perfect examples of materials similar to FeMnAl, the cracking responses can be compared to one another using these CPTT testing methods.

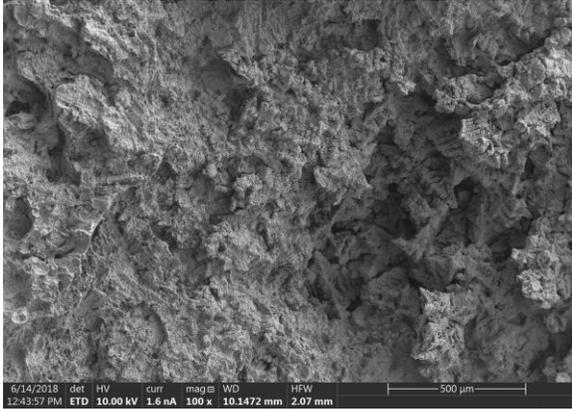
**Figure 13** Fracture surface exhibiting solidification cracking taken from a 1.5 inch pin that exhibited catastrophic failure.

Fractography was conducted on several of the cast pins that exhibited catastrophic failure, and a good example of the fracture surfaces observed is shown in Figure 16, and Figure 17. This fracture surface exhibits an example of a dendritic fracture mode which is common in solidification cracks. The solidification dendrites are quite apparent, and there is evidence of liquid films along the tips of the dendrites. This evidence points to a failure due to solidification cracking.

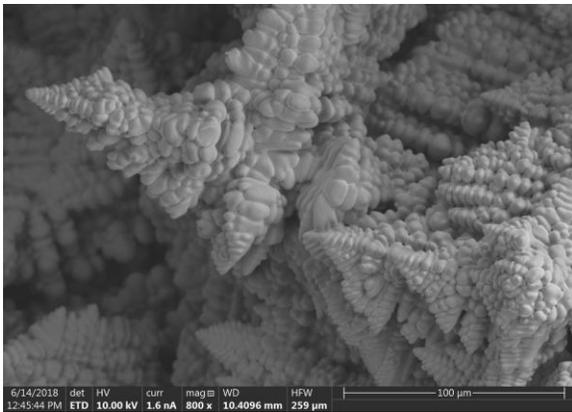
**Figure 14** Higher magnification view of fracture surface exhibiting solidification cracking taken from a 1.5 inch pin that exhibited catastrophic failure.
